MICROSCOPIC EXAMINATION OF STEEL

HENRY FAY, Ph. D., D. Sc.

*Professor of Analytical Chemistry, Massachusetts Institute of Technology
Consulting Metallurgist, Watertown Arsenal*

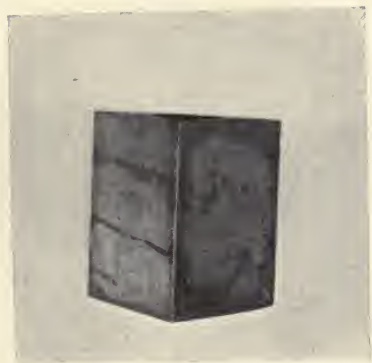
PHOTOGRAPH NO. 52.

Macrostructure of metal removed from 12-inch gun.

A section of the metal 1 inch square was cut from the region of the fracture, and the macrostructure was developed by etching with iodine solution. Photograph No. 52 shows the macrostructure in which is shown several streaks running parallel to the direction of forging on the left-hand face, and on the right-hand face an irregular area of segregation normal to this surface. Small fissures were visible and both faces indicated the presence of slag. Photograph No. 53 shows the microstructure on the longitudinal face in which is seen slag and small fissures. Photographs Nos. 54 and 55 show an unetched and etched area in the longitudinal face, some of the same slag areas being shown in each, and the lack of homogeneity of the metal is evident.

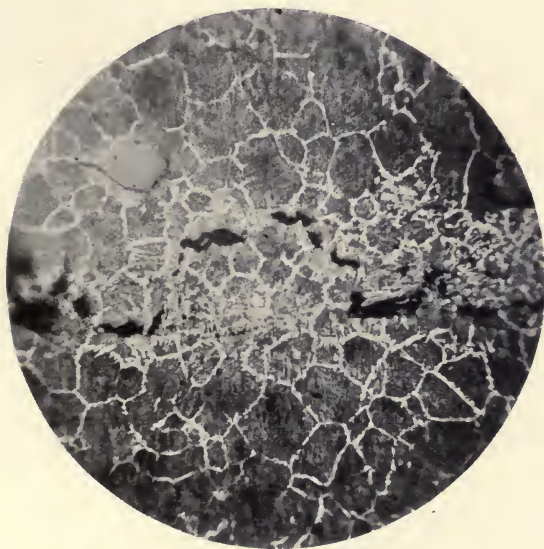
PHOTOGRAPH NO. 53. X50.

Twelve-inch gun. Microstructure showing slag and fissures.

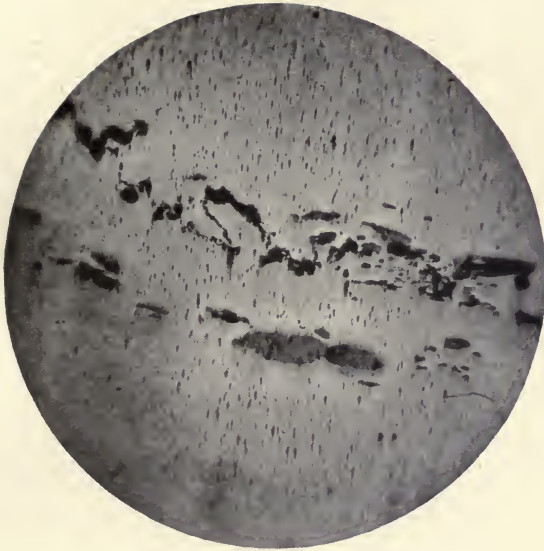
PHOTOGRAPH NO. 54. X50.
Twelve-inch gun. Slag in unetched specimen.

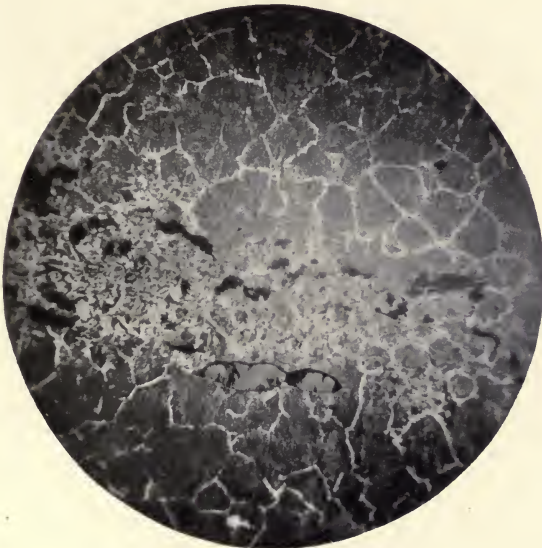
PHOTOGRAPH NO. 55. X50.
Twelve-inch gun. Same area as No. 54, etched with alcoholic nitric acid.
